Manhole Inspection Summary

Manhole # S29I__047MH

Insp Date: **9/8/08 11:56 AM**

Location Address: **100 Penn St**

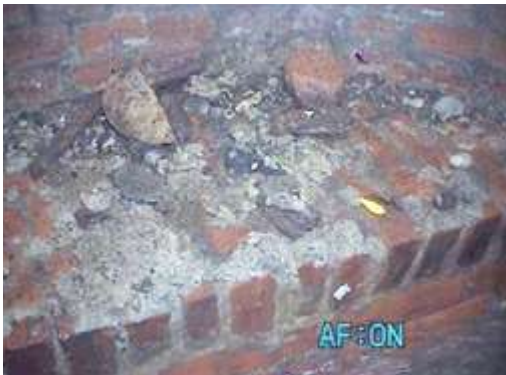
Miscellaneous

Condition: ☒ Sound ☐ Cracked ☐ Root Intrusion ☐ Deteriorated ☐ Leaks ☐ Debris

debris on bench

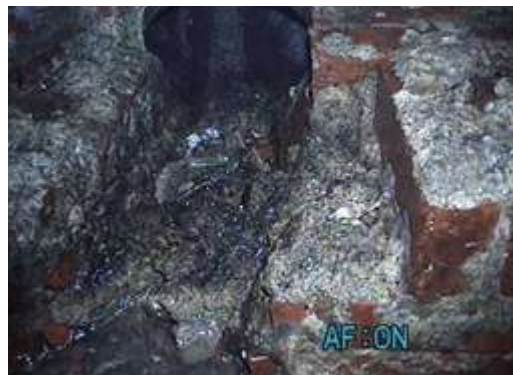
Defect 3

Condition: ☐ Sound ☐ Cracked ☐ Root Intrusion ☐ Deteriorated ☐ Leaks ☒ **Debris**

debris in channel

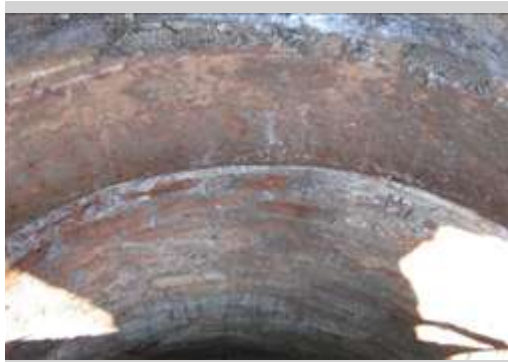
Defect 2

Infiltration: ☐ None ☒ **Joint** ☐ Cracks ☐ Mortar ☐ Roots ☒ **Wall**

infiltration

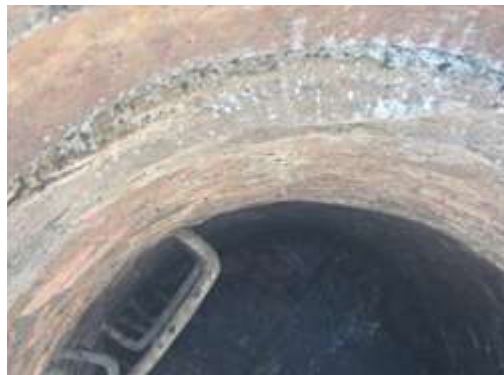
Defect 1

Offset: **2** (in.)

☒ **Leaks**

Count: **9** Missing: **0** ☒ **Corroded**

steps corroded, frame offset and leaking

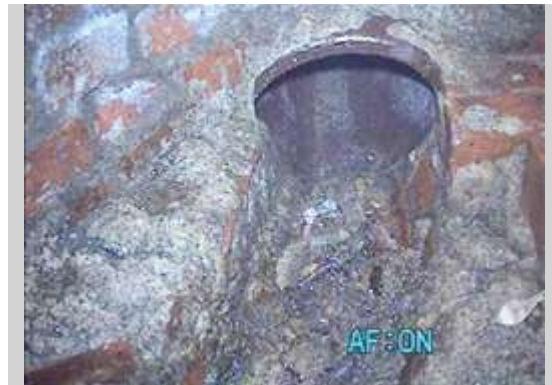
Drop In @ 2 OClock

Drop: **Inside** Rod and Bar
Angled: **Yes** Reading: **9.53** (ft.)
Inv Depth: **10.53** (ft.)
Drop Condition: **Clogged**
